The
San Francisco Earthquake and Fire

A BRIEF HISTORY OF THE DISASTER

A Presentation of Facts and Resulting Phenomena, with Special
Reference to the Efficiency of Building Materials
Lessons of the Disaster

A. L. A. HIMMELWRIGHT, C.E.

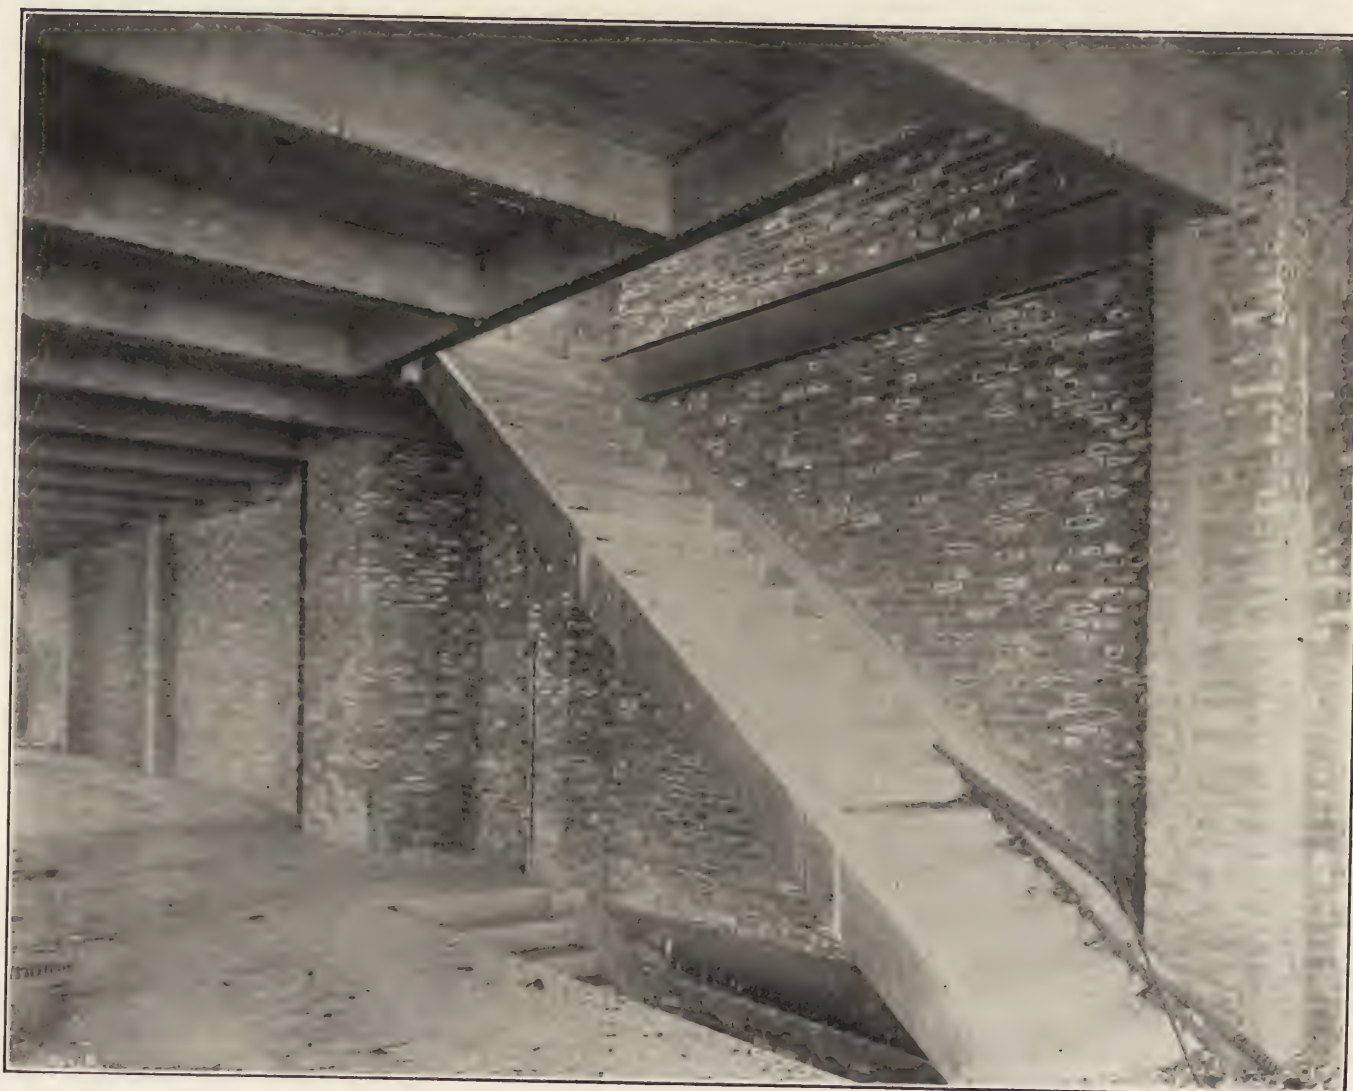
CALIFORNIA CASKET CO.'S BUILDING. Showing typical flight of concrete stairs between steel channel stringers. The crimped wire lath on the soffits of the beams had not yet been covered with cement plaster. The furring brackets at 16" centres on the wall girders in the stair opening are ready to receive the wire lath.

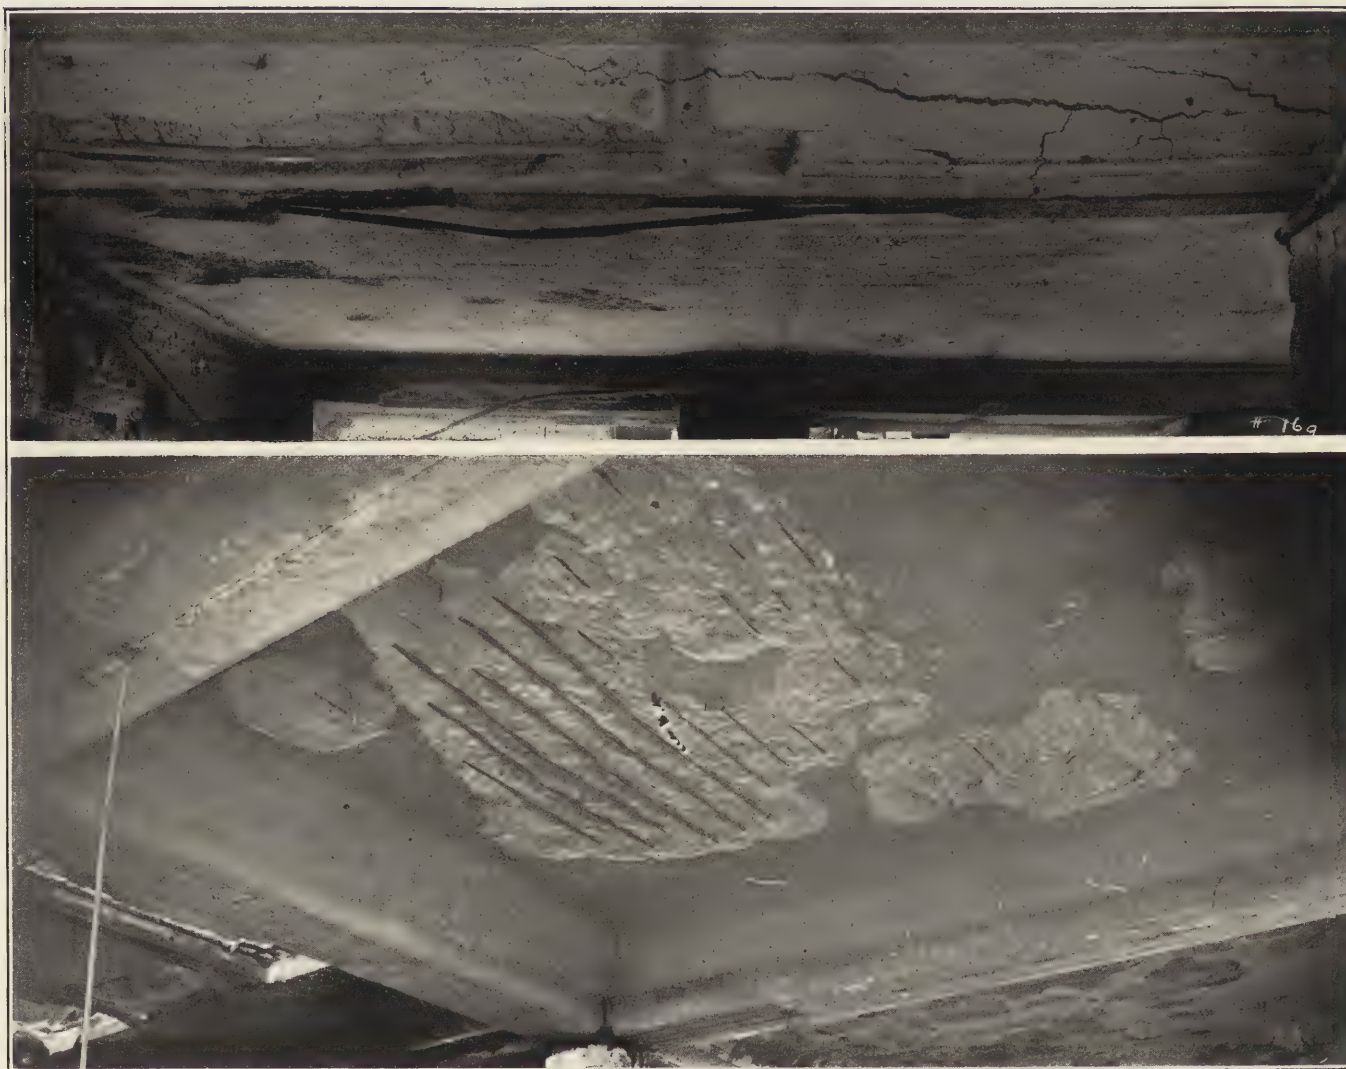
This building was subjected to only a moderate fire. Two double reinforced concrete beams in the basement are badly damaged, the concrete having fallen away, exposing six 1" square section Ransome twisted steel bars. In one bay fourteen consecutive reinforcing bars are exposed in the floor slab.

ACADEMY OF SCIENCE BUILDING. The upper view, taken in the basement story, shows the failure of a reinforced concrete beam. The fire spalled off the concrete on the under side of the beam and exposed six of the 1" square section Ransome twisted rods. This concrete beam still supports the wall above it, but is badly cracked.

The lower view, taken in the first story, shows fourteen consecutive $\frac{3}{4}$ " square section twisted Ransome rods, which have been exposed by the falling away of the concrete protection under them. Only a moderate fire caused the spalling of the concrete in both cases.

The falling away of the concrete protection under the reinforcing bars of the concrete beams and floor slab in the basement, from the effects of a very moderate fire, has considerable significance. The entire strength of a reinforced concrete beam depends upon the tensile members that are imbedded near its under side. When the protection falls away, and the reinforcing metal is exposed to fire, it is only a matter of a very short time until such small sections of metal become heated to temperatures at which they lose all their strength and failures result.

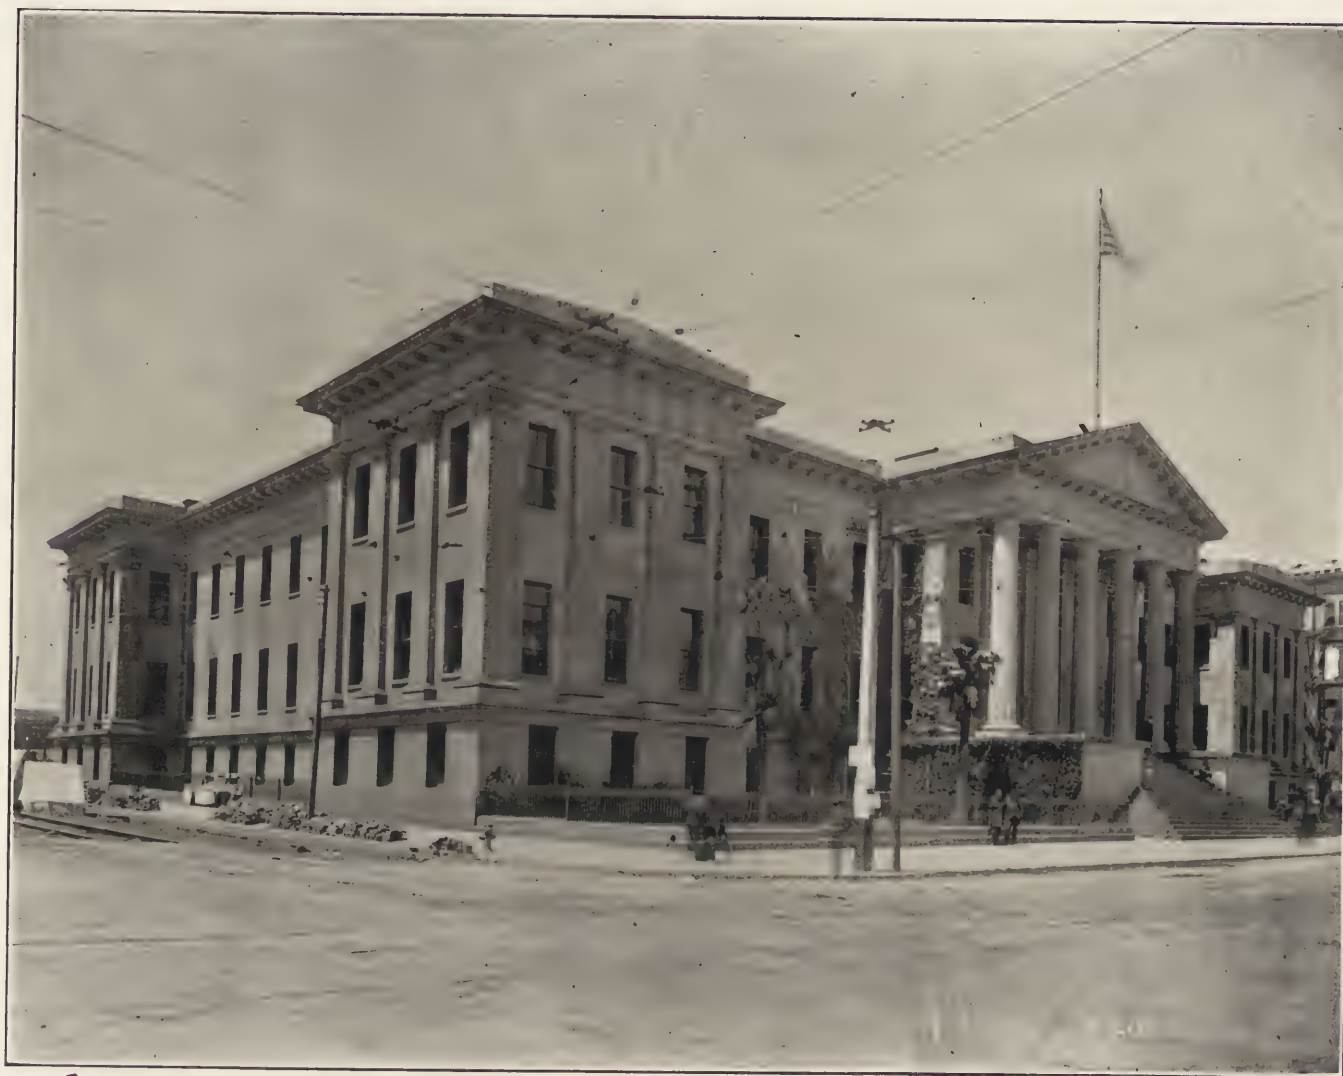
UNITED STATES MINT. Fifth and Mission Streets and Mint Avenue. This building of massive construction occupies an entire block with comparatively wide streets around it. The façades consist of granite for the basement story and limestone above. The foundations rest on piles. It had an independent water supply, and a large number of troops and employees successfully fought the fire when it invaded this section. The window openings throughout were protected by inside steel shutters. Except for a few spalled courses of brick on the west side of the south smokestack, this building was absolutely unharmed by the earthquake. In the centre section of the Mint Avenue side fire entered the building and caused slight damage before it was extinguished. The heat from adjacent burning buildings also spalled the limestone of the second and third stories on the north side.

The concrete floors are generally in good condition. The column protection is intact throughout. At the south side of the building in the first story were located filing cabinets which were full of paper. These made a fire of considerable duration, as is shown by a large quantity of white ashes. The plaster of Paris column protection of the three columns standing among these files is absolutely uninjured.

The interesting feature of this building is the column protection. The plaster work of the columns was composed of plaster of Paris instead of the ordinary lime mortar. Plaster of Paris is a well-known non-conductor of heat, and made an excellent showing against the fire in this building. It is, however, not a suitable material for the purpose of protecting structural members, for the reason that it absorbs moisture and is easily abraded and washed away by an ordinary fire stream. Plaster of Paris can, however, be economically and successfully used for column protection, as a filling behind metal column bases or other material which would form a protecting surface against abrasion from a fire stream.

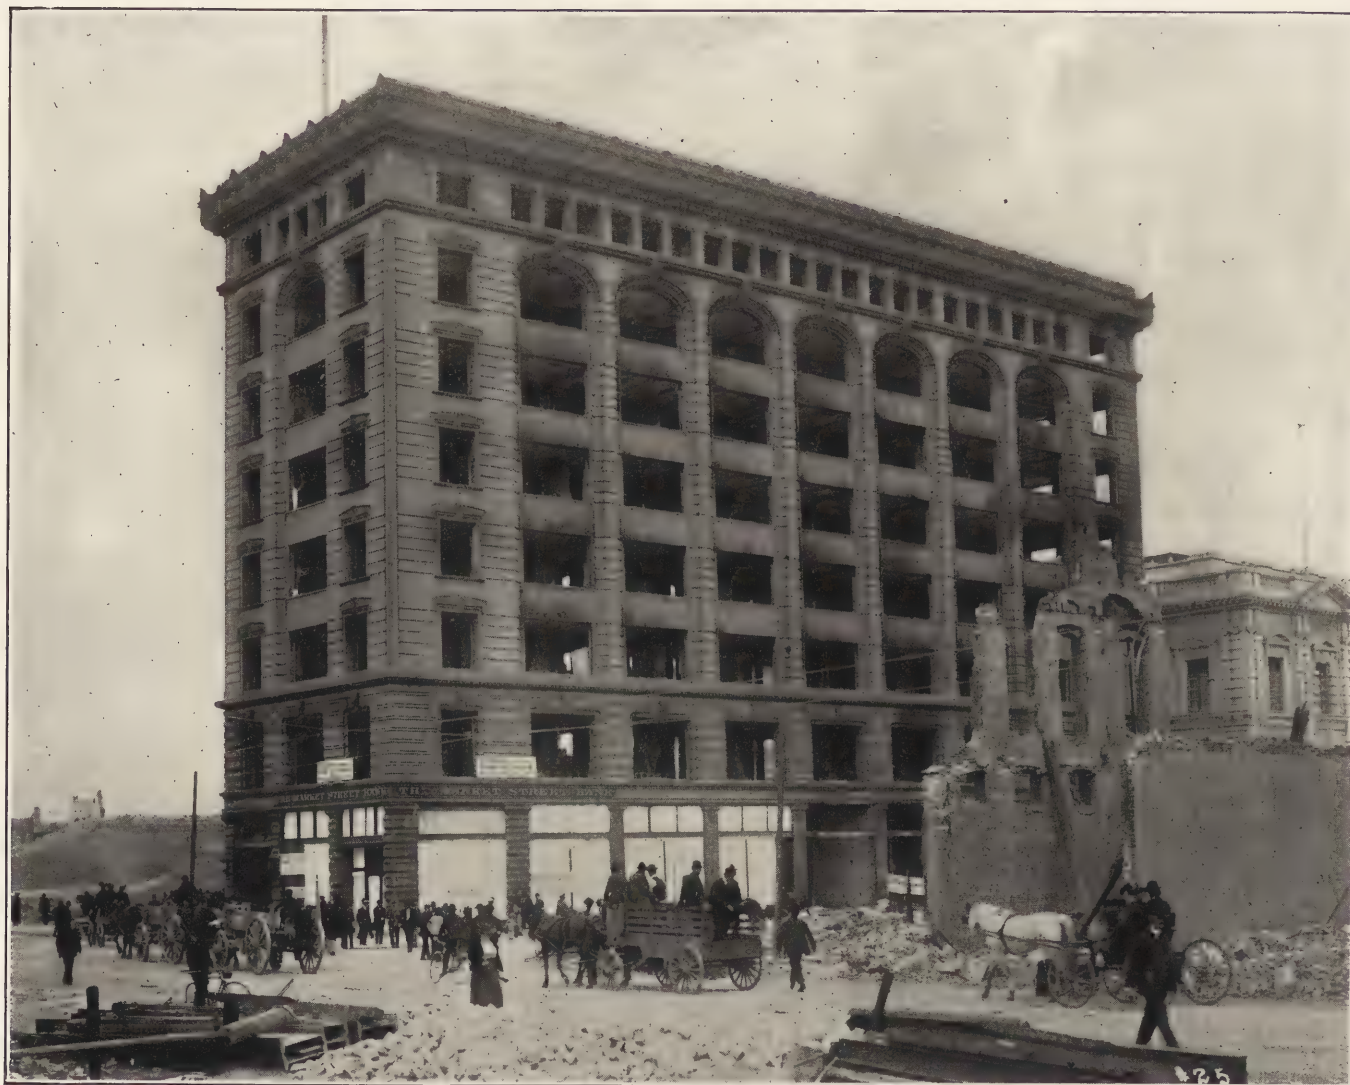
The Market Street and Seventh Street fronts are in very good condition, the sand-stone being but slightly spalled by the fire. The bases at the ground level are cracked and spalled. The east wall of common brick is in first-class condition. The south wall of pressed terra cotta brick is considerably damaged and cracked, the two lower stories being in the worst condition.

The levels on the water table indicate that the foundations have not been permanently displaced to any great extent, the corners differing in level less than $\frac{1}{4}$ ". The west wall at the northwest corner leans $1\frac{1}{2}$ " to the east. The north wall leans about $\frac{3}{4}$ " to the north.

GRANT BUILDING. Southeast Corner Seventh and Market Streets. The façades are only slightly damaged, but the rear walls are considerably racked and cracked by the earthquake. The Roebling fire-proof floors and ceilings throughout are in good condition. The 4" hollow-tile partitions are badly wrecked. The 3" hollow-tile column covering is damaged and off in many places.

The damage to the walls of this building by the earthquake and dynamite explosions is considerable, and large sections of the south wall will require rebuilding. The repairs of the interior will be limited to the restoration of the partitions, hung ceiling, plaster-work, wood trim and other finish.

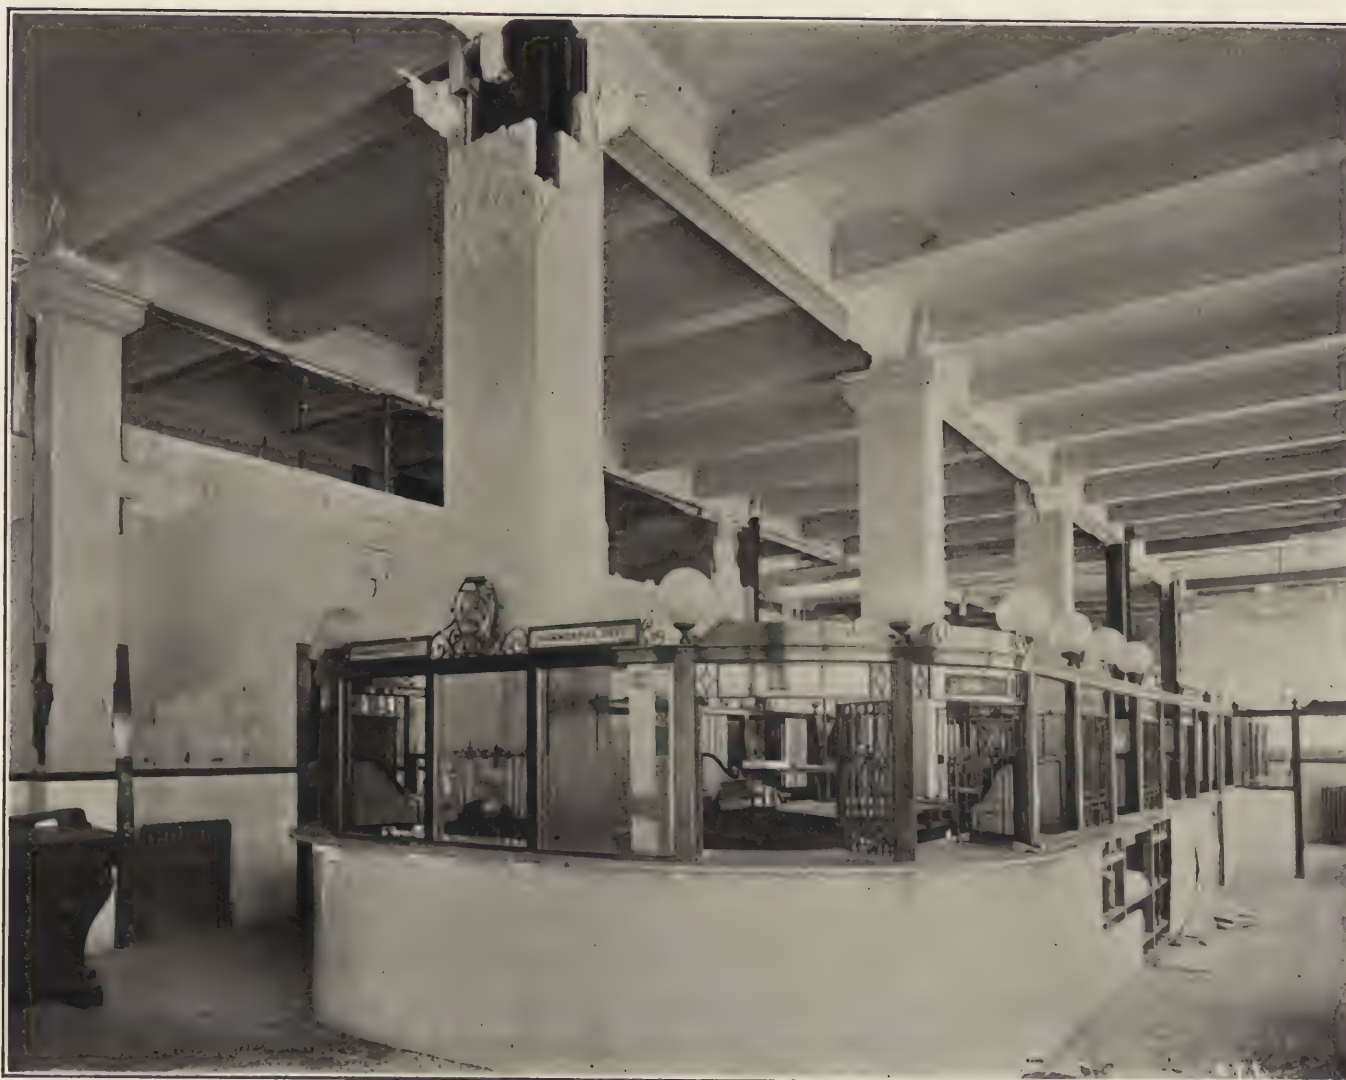
The steel frame of this building is uninjured. The banking room in the first story remains in good condition, having been untouched by the fire. The damage to the plaster work and to the large exterior windows in this room was caused by three heavy charges of dynamite that were exploded in the building on the opposite street corner. The concussion of these explosions no doubt contributed largely to the cracks and damage to the walls of this building. The rest of the building above the first story was fire swept.

GRANT BUILDING. First Story. Showing the banking room of the Market Street Bank. There was no fire in this room. The damage shown in the photograph was caused by the dynamiting of the Odd Fellows' Building on the opposite side of the street. Roebling concrete floors were used throughout. The column protection and partitions were of hollow tile. The fire consumed everything combustible in the rest of the building.

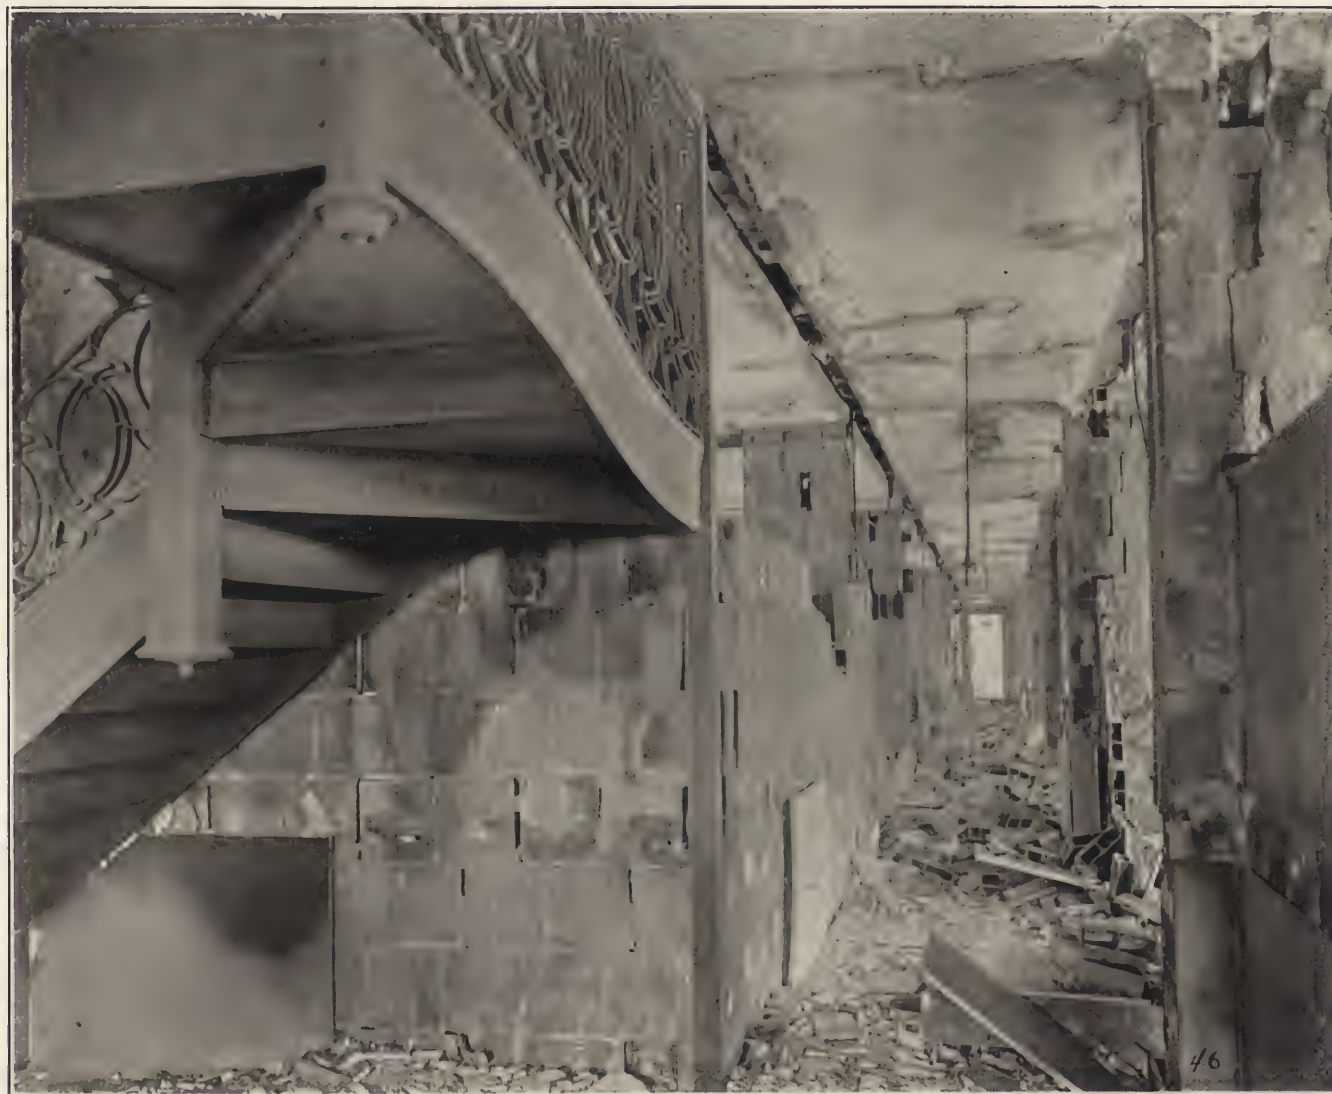
The elevator fronts at the different stories are considerably damaged and bulged. The cast-iron stairway with marble treads sustained considerable damage also, a number of the marble treads being broken. The concrete floors and wire lath ceilings throughout remain in first-class condition. The hollow tile column covering is damaged and sections have fallen away in numerous places.

GRANT BUILDING. Typical view showing the damage to the hollow-tile column protection and the failure of the hollow-tile partitions. The Roebling concrete floors and wire lath and plaster ceilings are in good condition throughout.

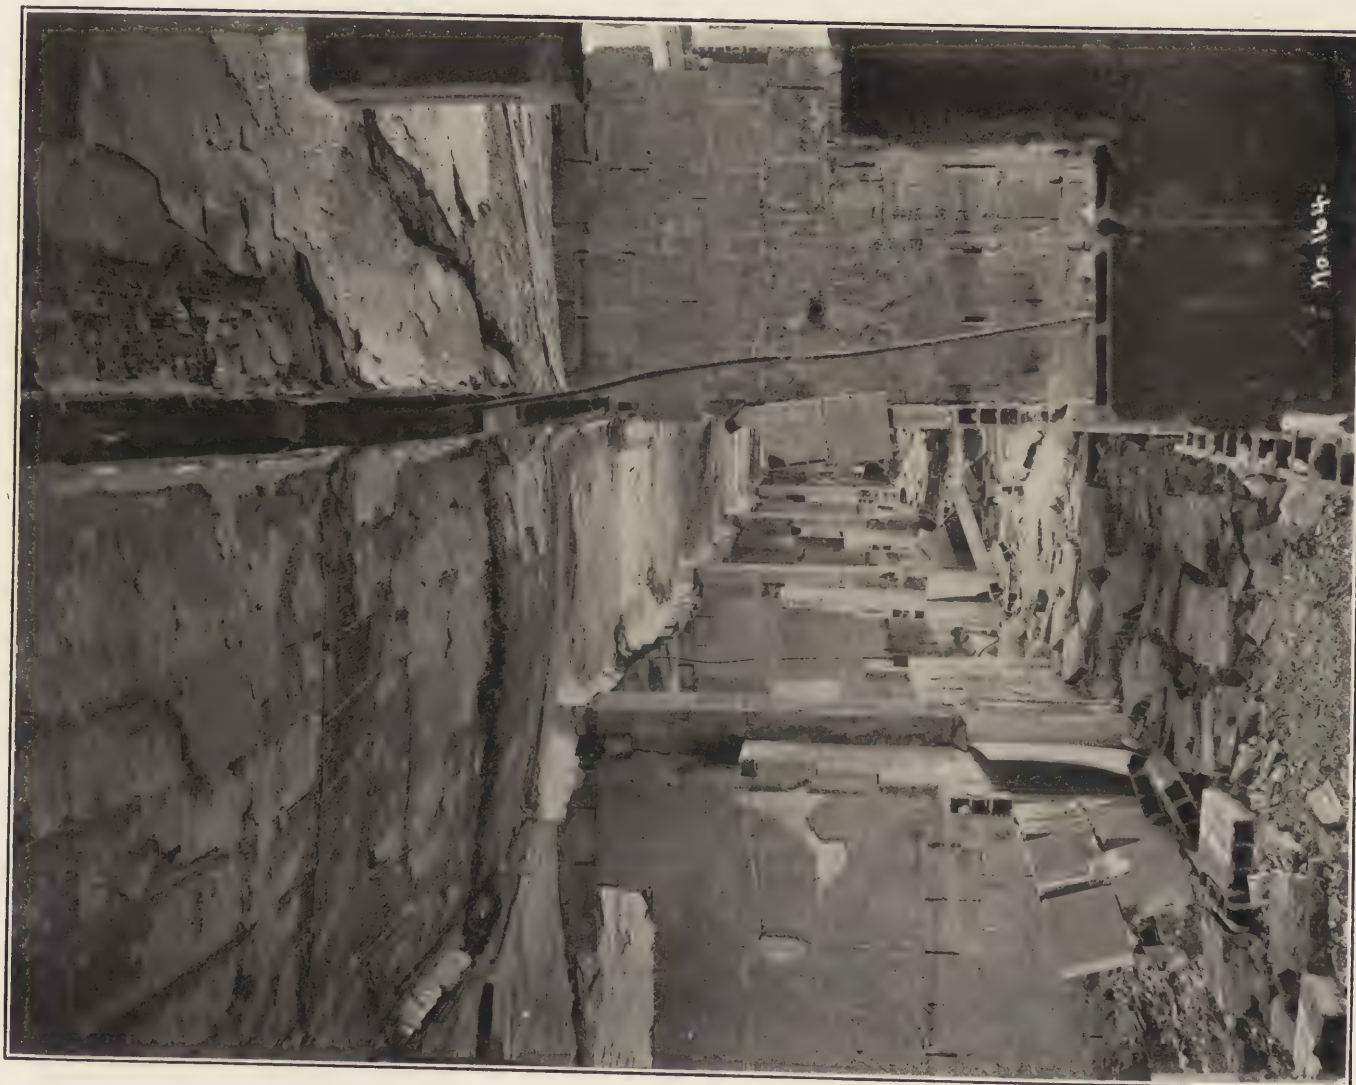
GRANT BUILDING. Eighth Story. Showing the damage to the hollow tile partitions and column covering. The partitions were carried through the suspended wire lath ceiling to the underside of the roof. The falling of the blocks between the ceiling and the roof sagged and damaged the ceiling in many places in this story, as shown. The wire lath ceilings in the other stories remain in first-class condition.

were carried through the hung ceiling to the under side of the roof slab. The portions of the partitions above the wire lath and plaster ceiling were shaken down, and falling on the top of the ceiling, broke it loose from the beams at some places, causing it to sag badly.

The mistake of carrying partition blocks through wire lath and plaster ceilings is clearly shown in the upper story of this building. The material served absolutely no useful purpose above the plaster ceiling before the fire, and when the partitions failed they left a slot 4" wide through which the fire had access to the space between the ceiling and the roof. In addition to this, the falling of the blocks above the ceiling level broke a number of the fastenings, so that large sections of the ceiling will have to be taken down and reconstructed. There being nothing combustible in the space between the suspended wire ceiling and the roof, the heat which entered through the cracks left by the partition blocks was not sufficient to injure the roof framing.

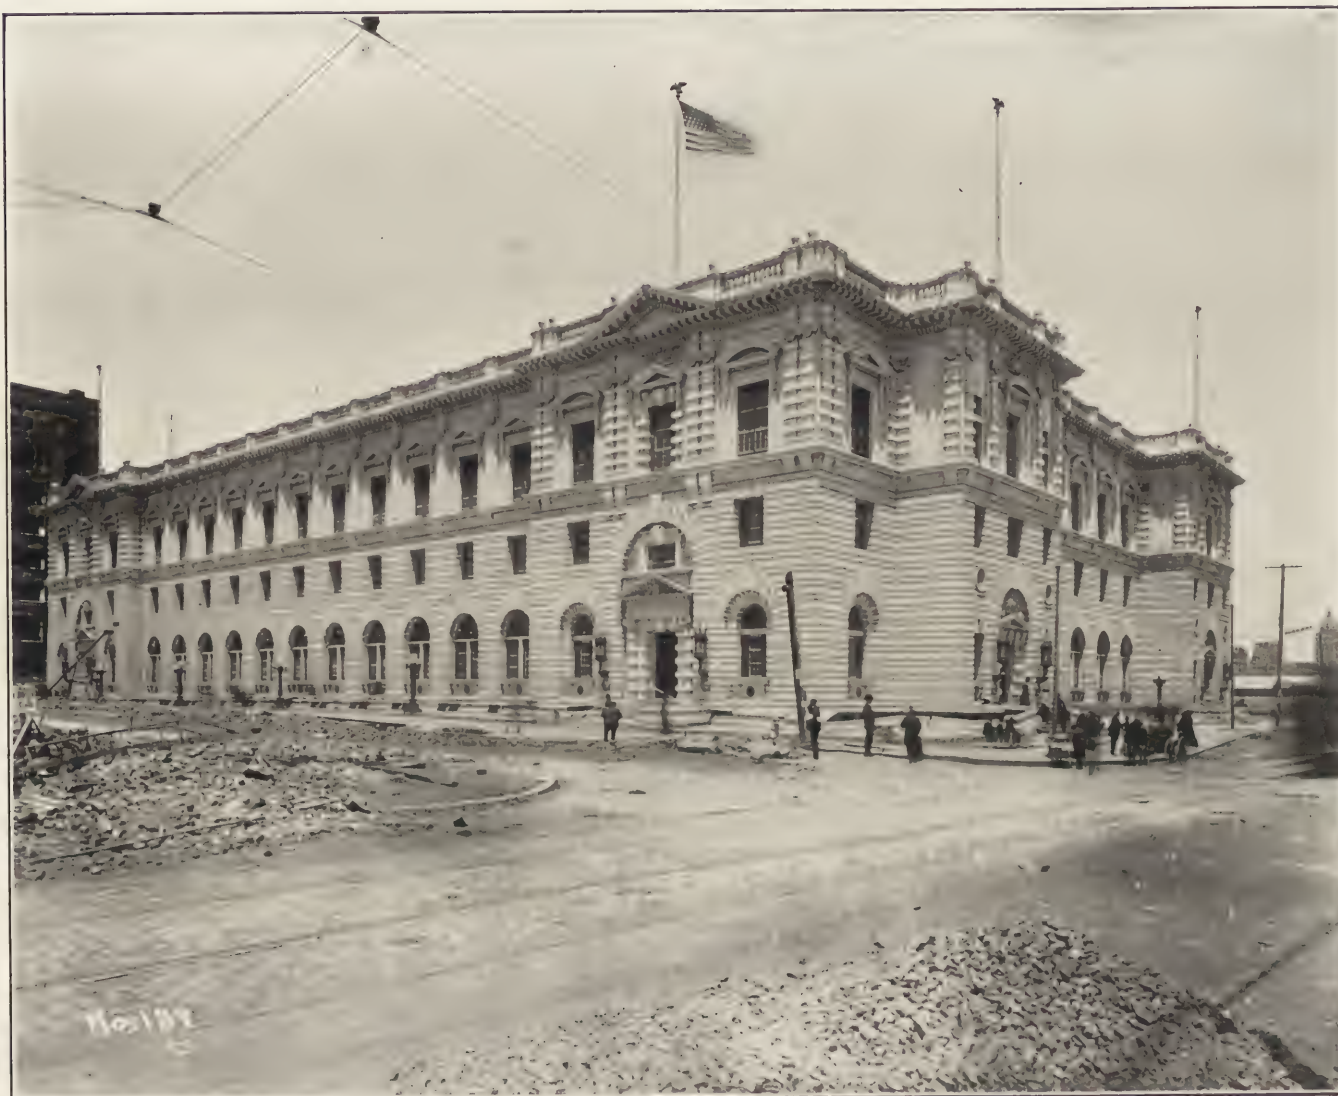
The front of the north side has extensive earthquake cracks, the granite facing of the east front is cracked loose from the backing and is temporarily braced at several places. The southeast corner is racked and a window head has one ring stone of the arch out and others loose. At the southwest corner, the ground settled about 2 ft. at the building line and about 5 ft. at the curb, the entire surface from the building line moving out about 5 ft. to the south. This distorted the sidewalk and steps of the two entrances, there being cracks in the joints of the cement sidewalk slabs 8" wide. It was necessary to place two temporary wooden steps of about 8" rise from the sidewalk in its settled position to that portion of the steps which remain approximately at the original height.

The levels on the foundations indicate that the northeast and southeast corners remain practically level, the northwest corner being about $\frac{1}{16}$ " higher and the southwest corner about $2\frac{1}{8}$ " lower, respectively. The plumbing of the walls indicates that they are very little out of plumb. At the northeast corner, the east wall leans to the east about 1".

UNITED STATES POST OFFICE. Northeast Corner of Seventh and Mission Streets. At the curb in front of the building, on the right-hand side, the ground settled 5 feet and moved to the east away from the building about 6 feet. At the building line, the ground settled about 2 feet, causing the displacement of the granite coping, steps, etc., at the sidewalk level, as shown. The sidewalk was originally a straight grade on the right-hand side where the sag is now shown. The northwest corner of the building was badly racked by the earthquake, and temporary shores were in position when the photograph was taken. This building was only slightly damaged by the fire.

Much of the facing of granite in the walls of this building is damaged and cracked, and will have to be taken down and rebuilt over considerable areas. The spalling of the granite from the effect of so insignificant a fire as the burning of trunks and parcels of clothing indicates how easily granite can be damaged by fire. This building should have been equipped with metal window frames and sash and wire glazing, or some form of efficient fire-resisting shutters.

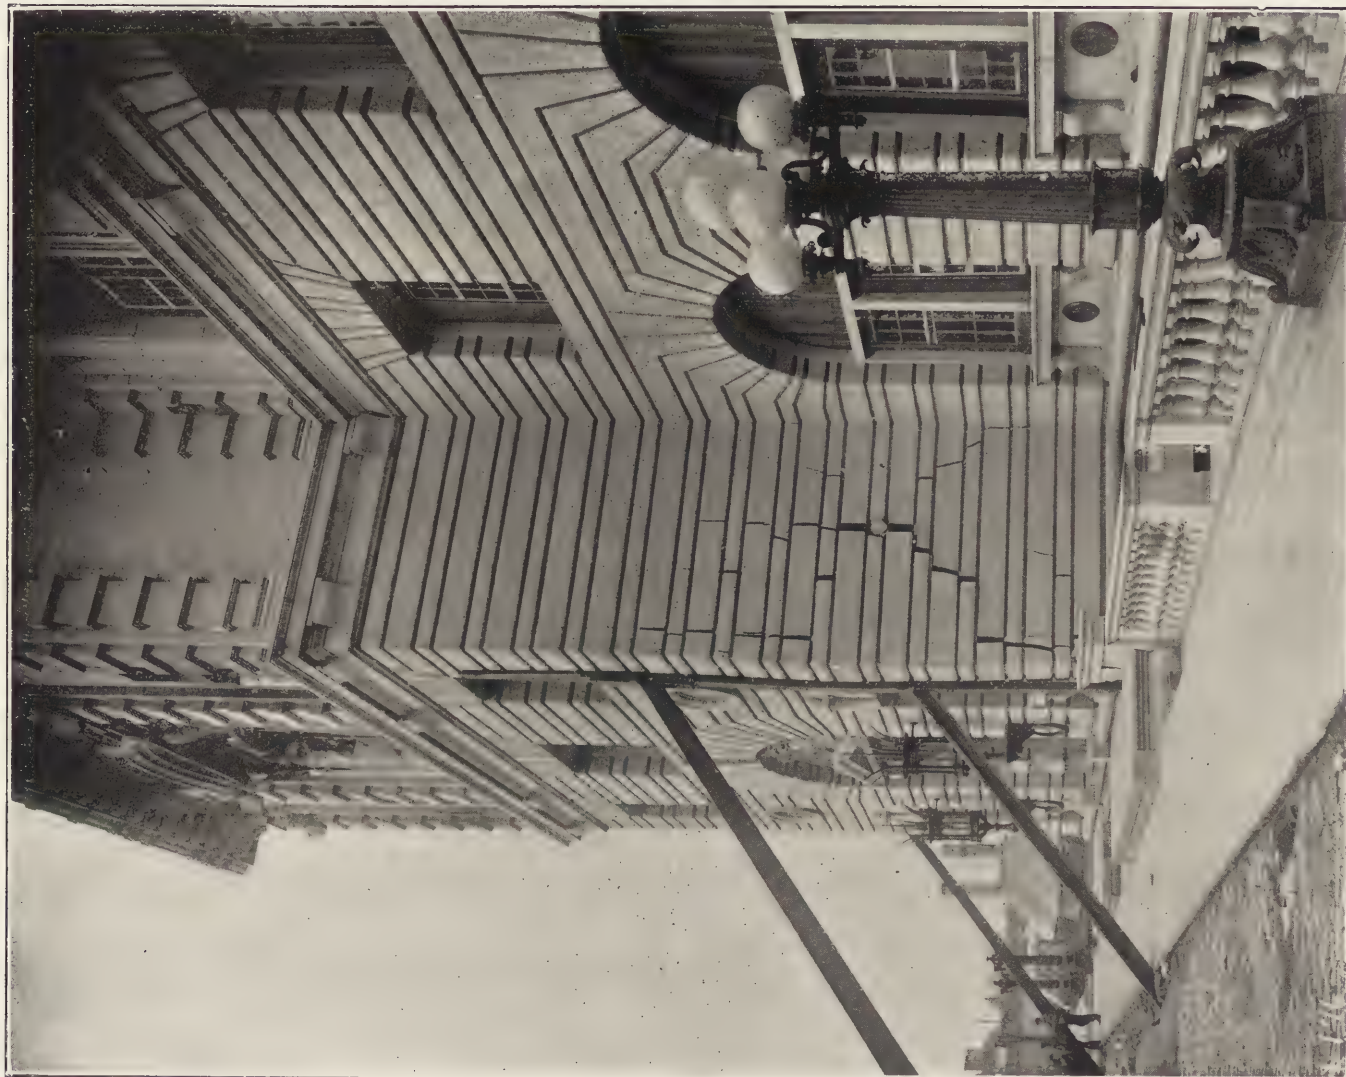
This building was protected by troops and employees while the fire was burning in this section. Fire entered the building only at the northeast corner in the third story. The window head at this point is considerably spalled by the fire and the combustible finish of one large room was destroyed before the fire was extinguished. Although the fire in this room was only of moderate intensity, it was sufficient to heat the copper wire with which the wire lath ceiling was laced to the supports, so as to weaken it sufficiently to allow the wire lath and plaster to fall

UNITED STATES POST OFFICE. Northeast corner Seventh and Madison Streets. Showing the earthquake damage at the northwest corner of the building. Also showing the window at the third story level through which the fire entered one of the rooms. This was the only portion of the building damaged by fire. Troops and employees successfully fought the fire and prevented it from doing material damage. There was originally a creek at the present location of the Post Office, rendering the conditions especially difficult for providing a stable foundation.

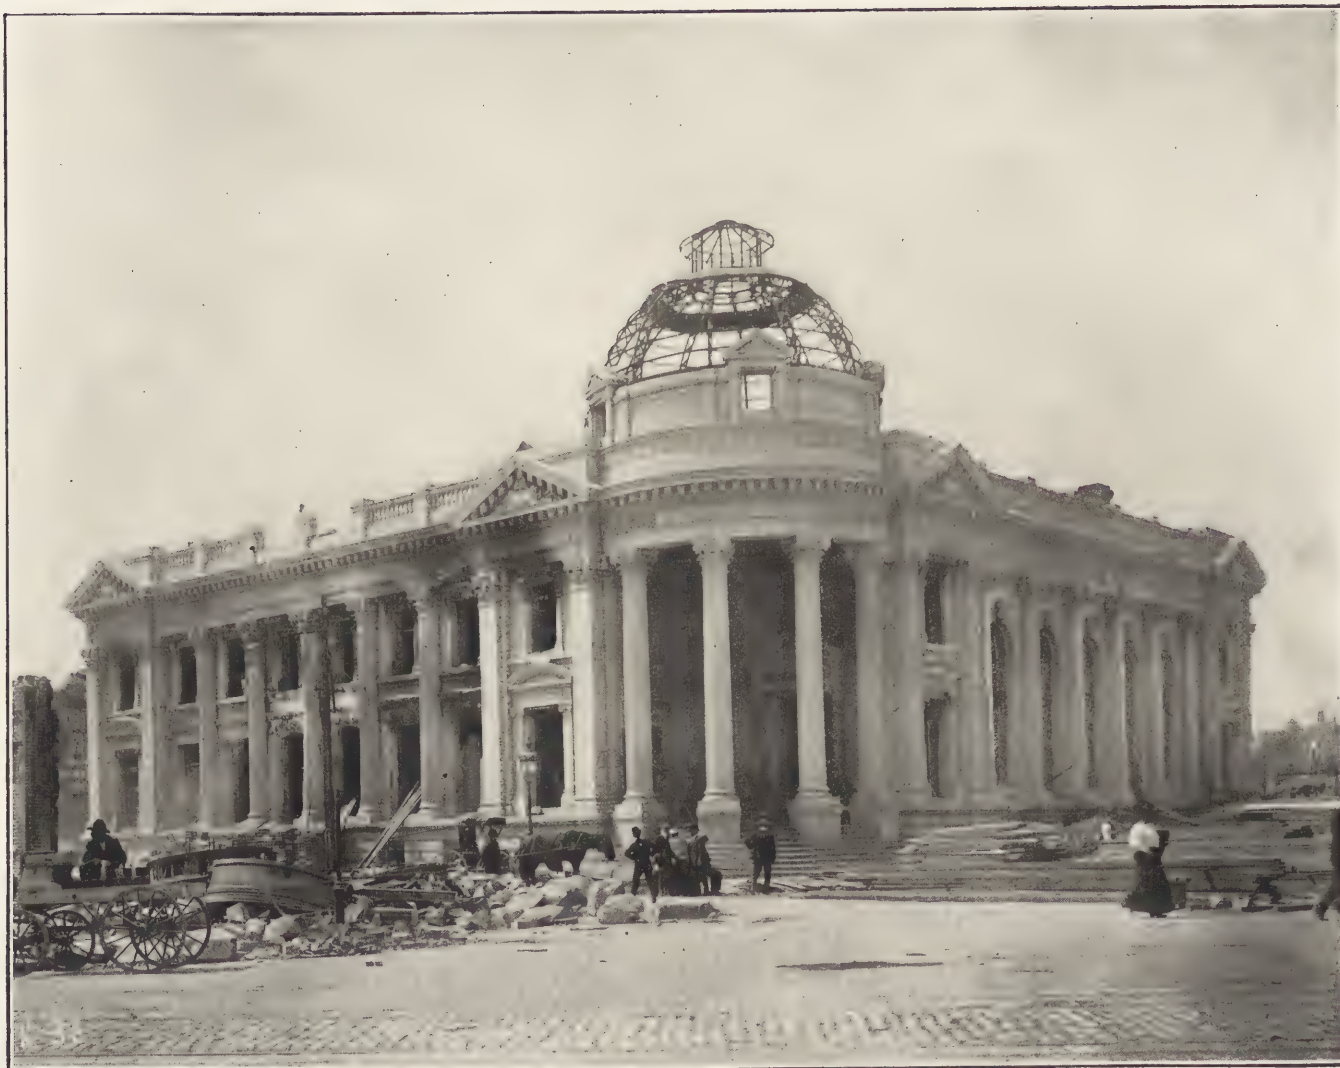
The window heads in the middle portion of the McAllister Street front are much spalled by the fire from the interior. The entire Jones Street side is badly damaged and spalled by heat from the burning buildings on the opposite side of the street. There are no perceptible earthquake cracks in the façades. The north wall is in good condition. In the west wall, the granite work is badly spalled from the heat of adjoining buildings. The window heads are also badly spalled by the fire from within.

HIBERNIA SAVINGS & LOAN SOCIETY BUILDING. The façades of gray granite are considerably injured. The window heads in the middle portion of the McAllister Street front are badly spalled by fire from the interior. The entire Jones Street side is scaled and spalled by heat from burning buildings on the opposite side of the street. There is little earthquake damage. The segmental brick and concrete floor arches and the wire lath ceilings remain in good condition. The Roebling ornamental furring and lathing work is uninjured, but the plaster finish is damaged by earthquake cracks and smoke.

This building sustained very little structural damage. The Jones Street façade was ruined by the burning of buildings on the opposite side of the street, and will require complete renewal. The McAllister Street front, and the damage to the north and west sides, can be repaired. The repairs to the interior will consist of plaster work and finish.

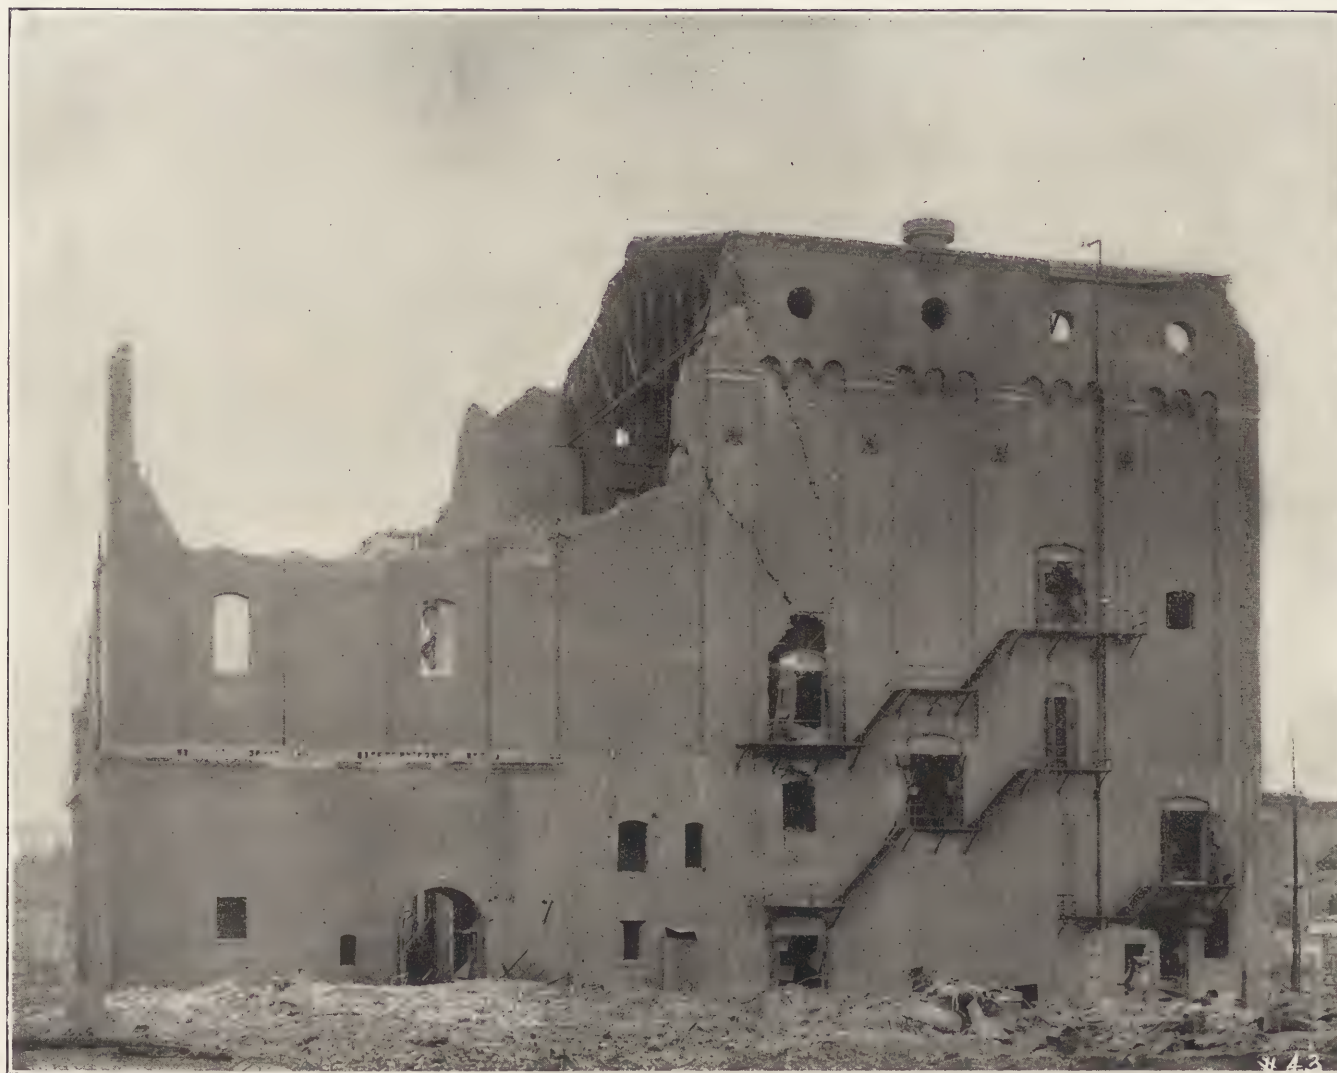
The east wall is down on the south side. A large section under one of the roof trusses is cracked loose from the east wall, and has moved about 4" laterally, as is shown by the pilaster on the outside, which is about 4" out of line at the fracture.

MAJESTIC THEATRE. Northeast Corner Ninth and Market Streets. This building had an entrance by an arcade from Market Street through a Class B building, which was destroyed by the fire. All the walls are bearing walls and of common brick with terra-cotta ornamentation. The left-hand side is the stage portion of the building, and was totally wrecked by the earthquake. The gable wall at the opposite end of the building was also shaken out, large portions of the brickwork falling upon the gallery tier and being supported by it. Roebling concrete floors and ornamental furring and lathing were used throughout. Note the floating section of brick wall cracked loose and supporting a large truss of 75 feet span, about 80 feet above the ground. The loose section of the wall has moved horizontally so that the side of the pilaster is 4 inches out of line.

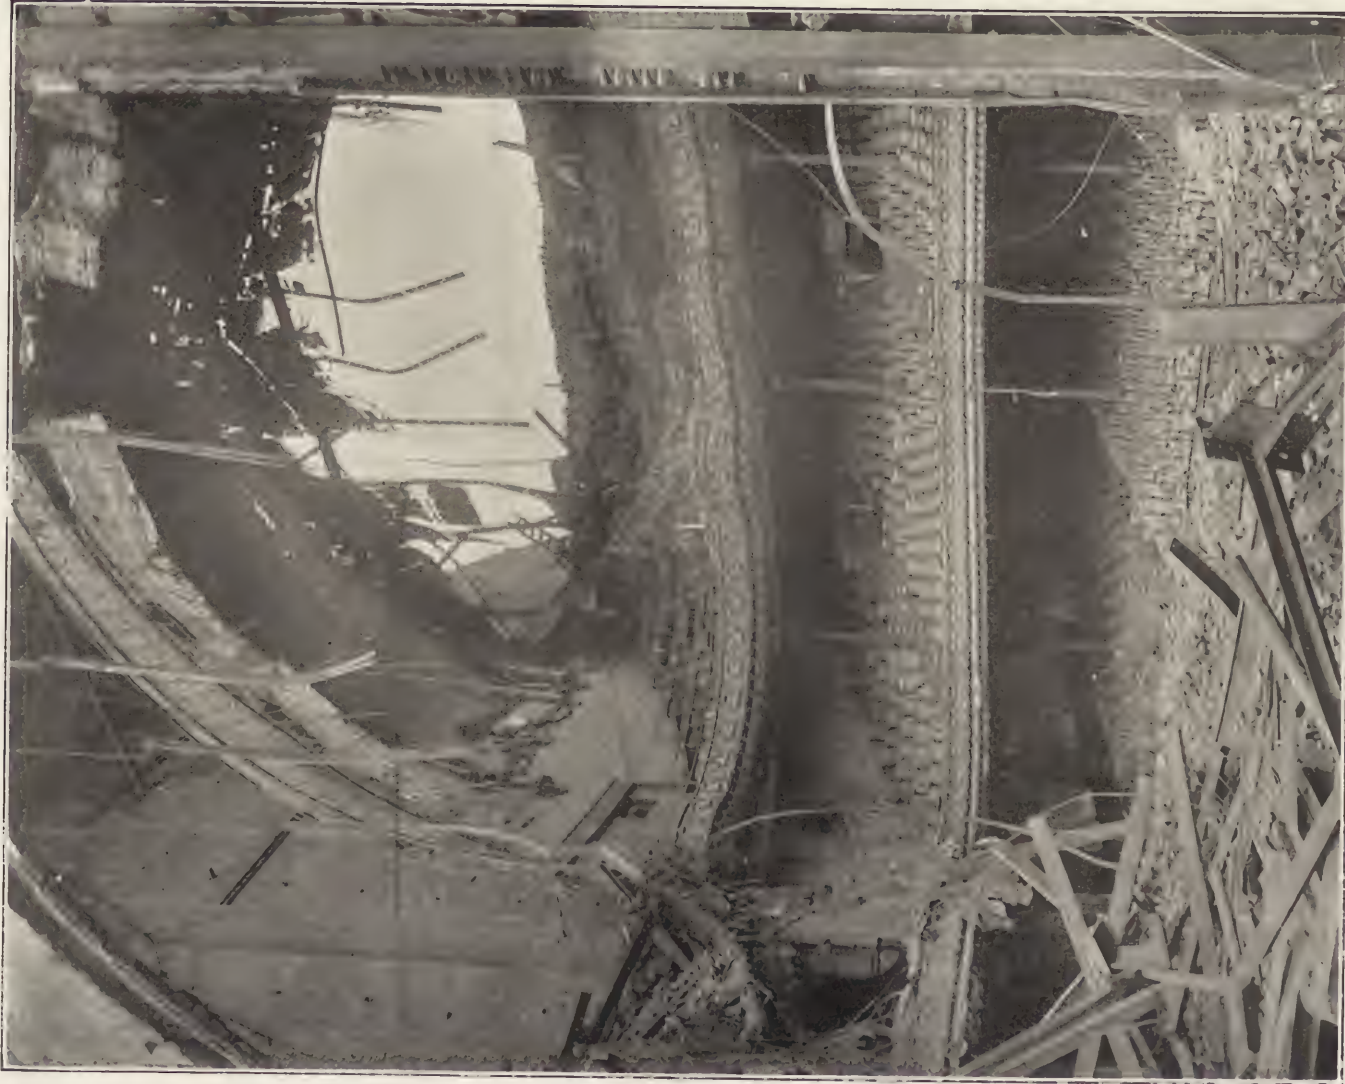
A large section of the ornamental lath and plaster ceiling over the auditorium is still in position under the remaining portion of the roof. All the combustible finish and furniture of the auditorium, balcony and gallery have been consumed, the metal work of the seats and the concrete floors only remaining. In the portions of the building that have not collapsed the steel framing and the concrete floors remain in first-class condition.

MAJESTIC THEATRE. Southeast Corner Ninth and Market Streets. Showing the interior, looking toward the auditorium. The wall in the rear, above the gallery, was shaken down by the earthquake. Everything combustible in the auditorium was consumed, leaving only the castings of the seats in position. The ornamental ceiling over the auditorium, of wire lath and plaster, is still in place between the wrecked portions of the roof. Note the enormous load of brick from the rear wall which fell on the gallery tier, and is supported by it. Roebbing fire-proof floors with a cement top finish were installed throughout and are in good condition.
